Cruise Report for R/V *Kilo Moana* KM-14-23: ALOHA Cabled Observatory Service 29 October – 3 November 2014

3 November 2014

Bruce Howe, Chief Scientist

Department of Ocean and Resources Engineering School of Ocean and Earth Science and Technology University of Hawaii

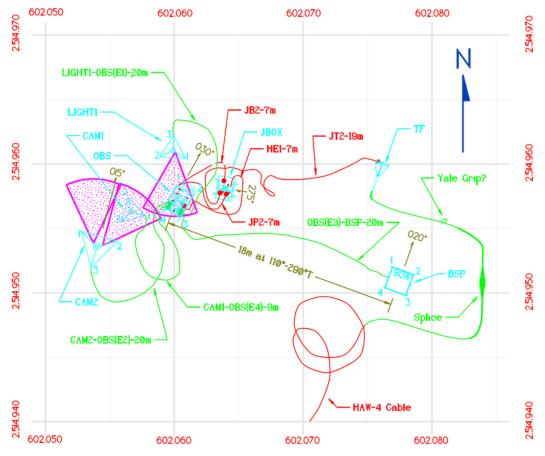
Figure 1 ACO planned bottom configuration (final is very similar).

The pre-cruise planned layout of components has been shown in Figure 1. The actual layout is almost the same, the single exception is we did not move the main sea cable, but laid the BSP cable over it. After the photo-mosaic data is worked up a new map will be made. A block schematic of components and connections is given in Appendix A.

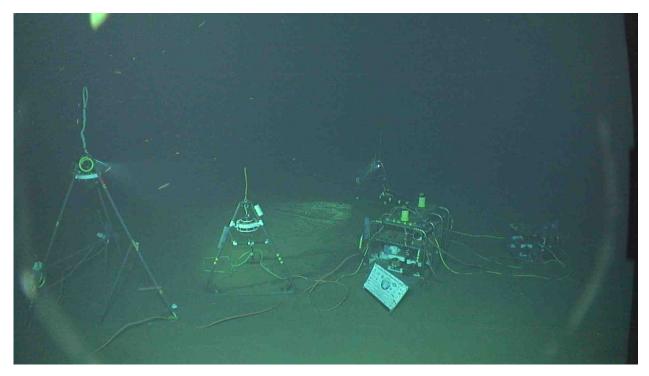
Figure 2 ACO as viewed by Jason. The Basic Sensor Package (BSP) is to the right 18 m.

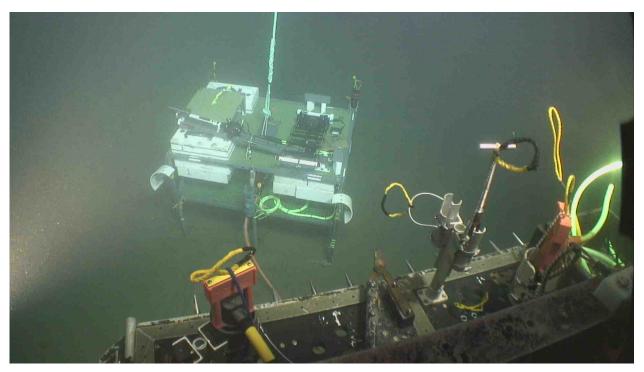
Figure 3 ACO Basic Sensor Package (BSP) as viewed by Jason, just prior to raising masts and preparing for transfer of buoyancy to the AMM secondary node.

To recover the non-functional AMM secondary node, we transferred a 3-ball buoyancy package from the BSP to the AMM (initial testing on the ship after recovery indicated a dead short on the AMM, indicating the fault is internal, and not the connecting cable). The seawater ground had built up a shell of aragonite that was easily removed. We recovered several ODI connectors and pin-protecting dummies from the previously deployed TAAM mooring. A banner was emplaced that shows all the organizations that have contributed to the ACO.

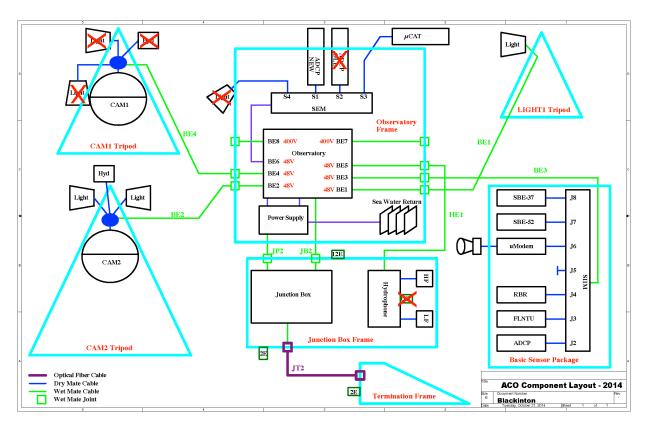
Figure A-1 ACO bottom interconnection diagram – 2 November 2014

The following diagram shows components of ACO in a schematic form, naming frames, connectors and cables, pressure cases and endcaps, sensors, etc. The FLNTU had a ground fault and is not working. It is unknown at this time if the pressure sensor is functional – it is communicating, but reporting off-scale values.
