**Cruise Report for R/V *Kilo Moana* KM-23-12A,B:
ALOHA Cabled Observatory Service
and
Deep Water Sentinels Deployment
19 August – 27 August 2022**

Summary

The ALOHA Cabled Observatory 100 km north of Oahu at Station ALOHA is the deepest (4728 m) power and internet node on the planet, returning oceanographic data from the seafloor in realtime to shore. The ACO has been operational with plug-and-play capability since 6 June 2011. On this cruise we serviced the Observatory, installing a new hydrophone and removing two failed cameras.

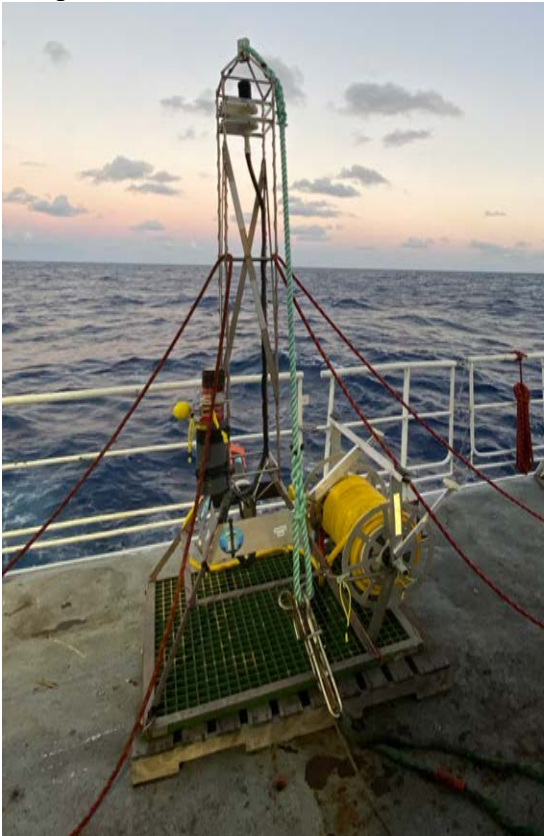
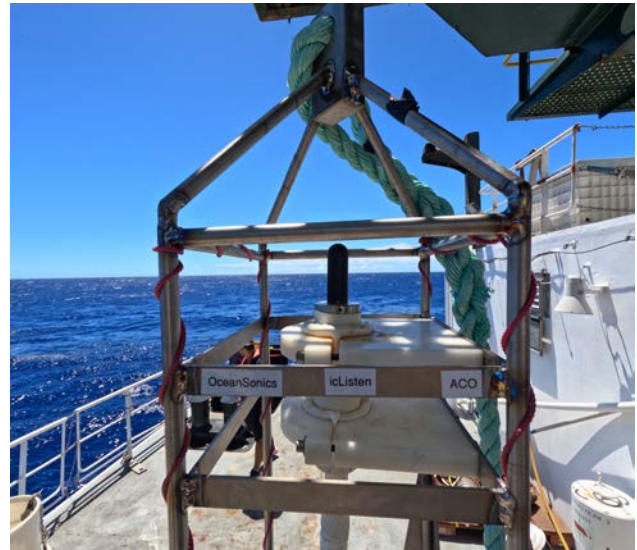
The hydrophone is 2.5 m off the bottom (at 4728 m) within a flow shield consisting of a sock on a plastic frame.

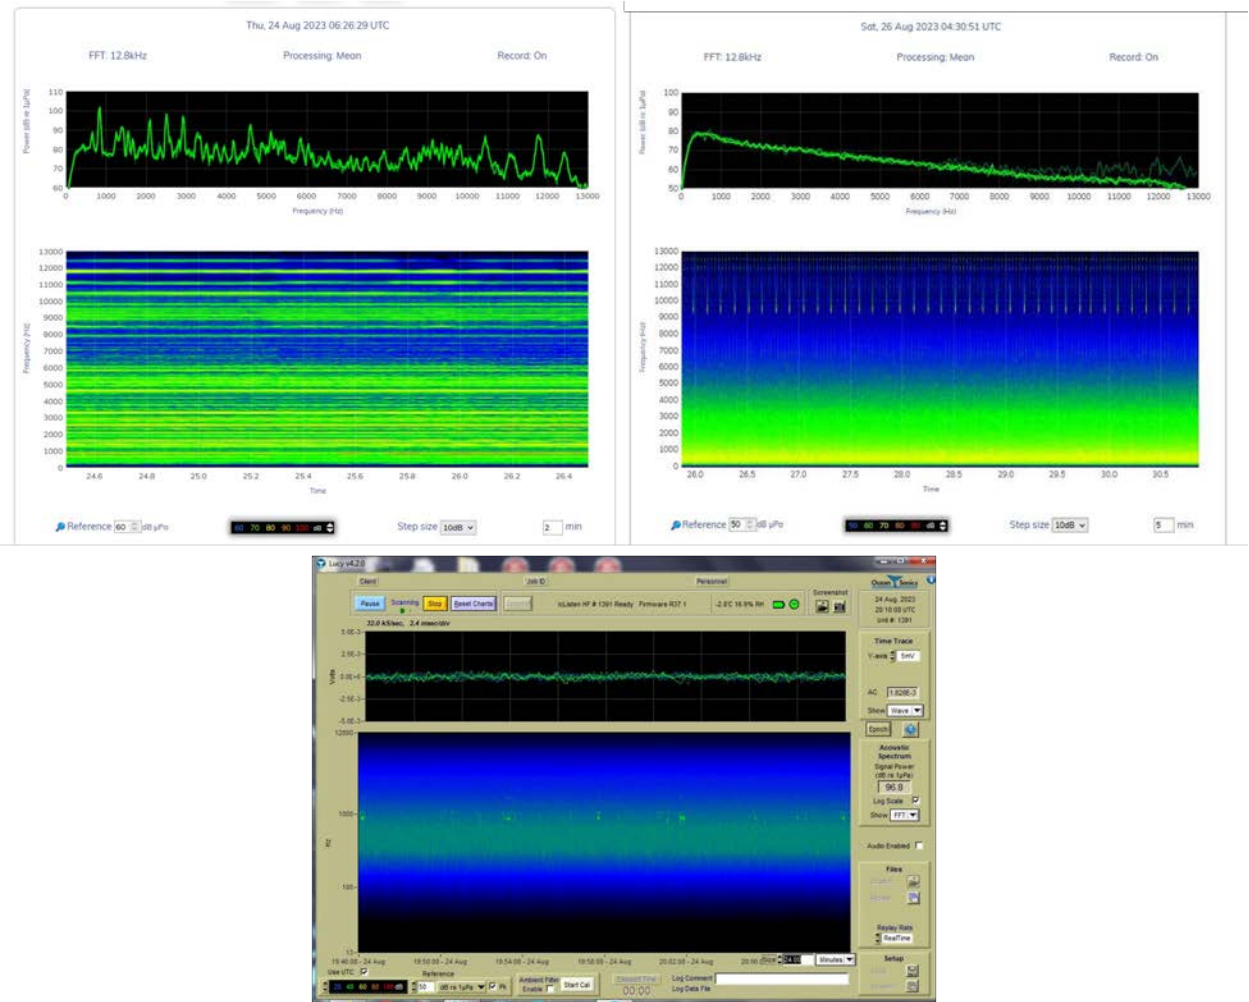
Shown above are spectra and spectrograms from the iClisten after deployment. The first one shows data with the ROV close by. The second shows high frequency signals from the ship: a Benthos interrogator signal at 9.5 kHz being transmitted every 7 seconds, and the higher frequency signal every 2 seconds is the leakage from the 20-35 kHz ultrashort baseline tracking signals. The last figure shows what might be sperm whales at about 1 kHz (log scale). Comparisons with the other ACO HEM hydrophone show the same signals.

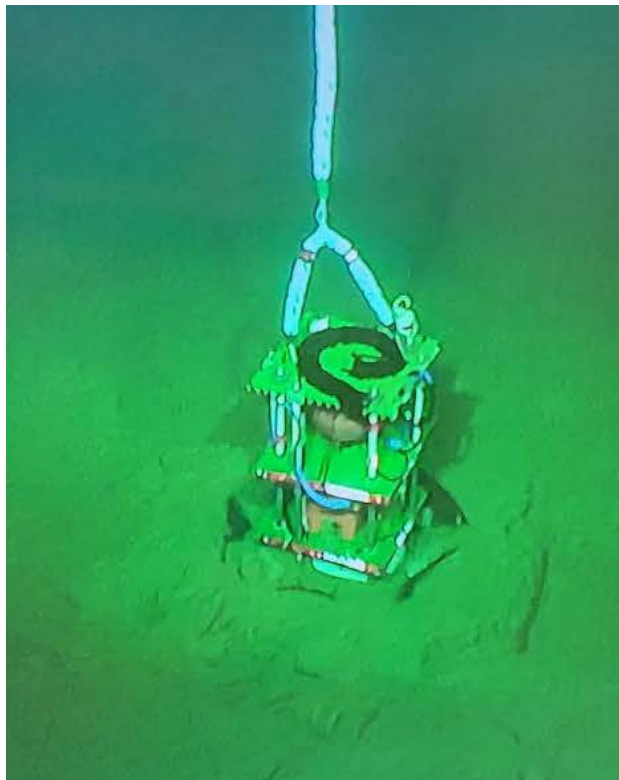
The very first task before the landers were moved was to collect water samples to establish the a priori water state. After the three landers were sealed by ROV plowing, the ROV took four sediment push cores. Then each lander was inspected after the sediment plumes had time to settle away. Landers C and B looked completely sealed around all sides. Lander A revealed one remaining gap, so the ROV was used to plow at that location and seal the gap. The figure below shows the final state of Lander B.

Lander B on the bottom after plowing.

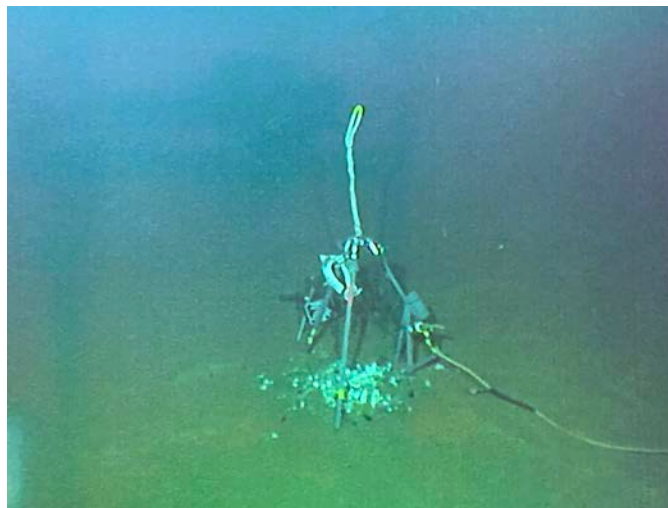
However, upon seeing it for the first time (figure below), it was clear the glass sphere had imploded, just leaving a few plastic and metal chips below. It appears the nearby lights and hydrophone on the frame survived; the frame itself was only slightly damaged where the equatorial ring connected.

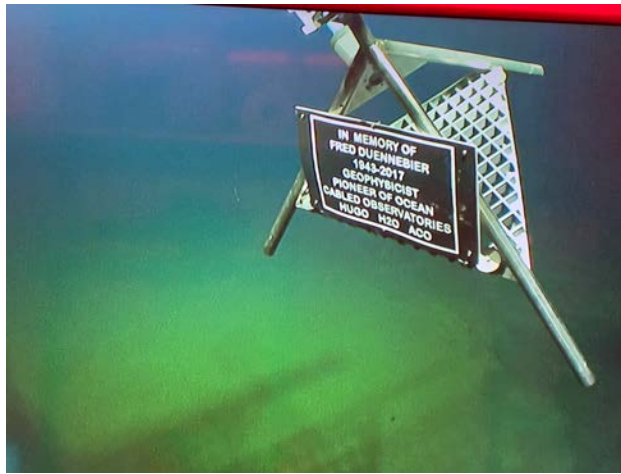
The image below shows the memorial plaque for Fred Duennebier, that serves as a parking position, now at the end of the PEA from Secondary Node 1 (SN1) Port J2, for the flying connector.
